# Manhole Inspection Summary

Manhole # S59AA\_005MH

Insp Date: **2/22/10 4:42 PM**

**Location** Address: **PULASKI HWY**

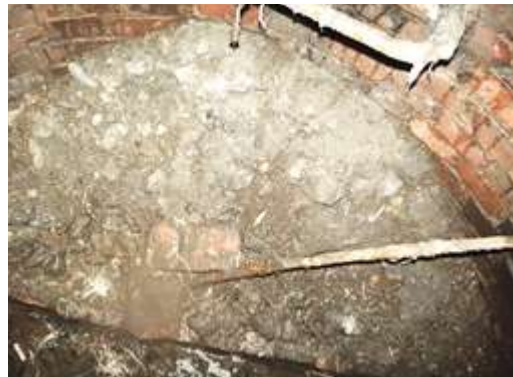
Defect 2

Condition: ☐ Sound ☐ Cracked ☐ Root Intrusion ☐ Deteriorated ☐ Leaks ☒ **Debris**

debris

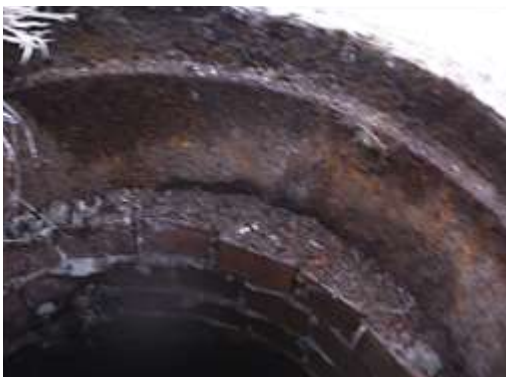
Defect 1

Offset: **2** (in.)

☒ **Leaks**

offset

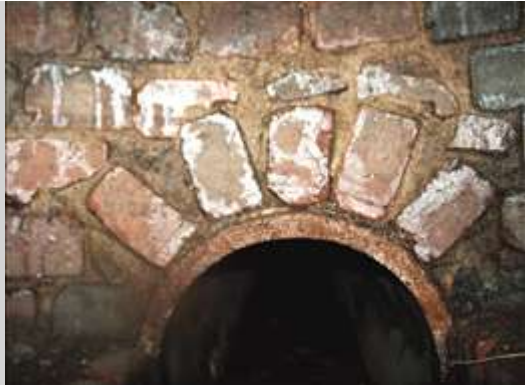
12 O'Clock Outflow

6 in. Circular Gravity Sewer  
Pipe Out @ 12 O'Clock

Pipe Height: **12** (in.) Rod and Bar (Angled)  
Pipe Material: **Clay** ☐ Pipe Lined  
Invert Depth: **8.92** (ft.) Flow Characteristics: **Slow**  
Deposits: ☒ None ☐ Mud ☐ Sludge ☐ **Debris** ☐ Grease  
Silt Depth: (in.) Deposits Extent:  
Infiltration: **None** Pipe Seal Cond: **Sound**

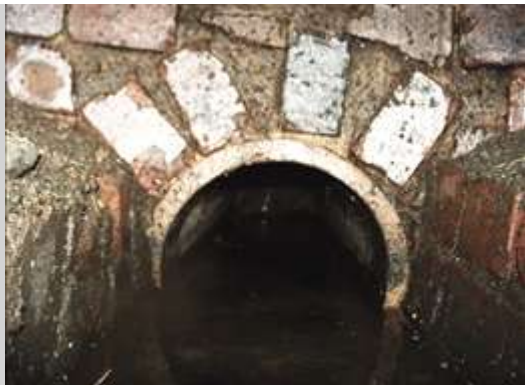
6 O'Clock Inflow

8 in. Circular Gravity Sewer  
Pipe In @ 6 O'Clock

Pipe Height: **12** (in.) Rod and Bar (Angled)  
Pipe Material: **Clay** ☐ Pipe Lined  
Invert Depth: **9.08** (ft.) Flow Characteristics: **Slow**  
Deposits: ☒ None ☐ Mud ☐ Sludge ☐ **Debris** ☐ Grease  
Silt Depth: (in.) Deposits Extent:  
Infiltration: **None** Pipe Seal Cond: **Sound**

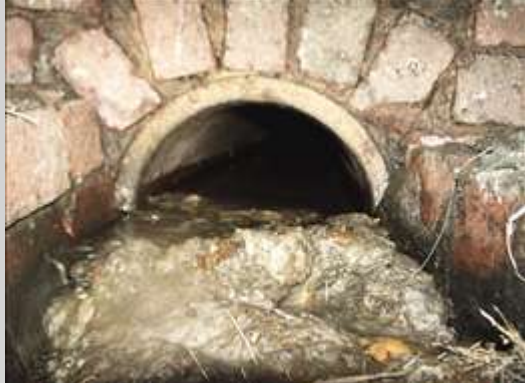
8 O'Clock Inflow

8 in. Circular Gravity Sewer  
Pipe In @ 8 O'Clock

Deposits: ☐ None ☐ Mud ☐ Sludge ☒ **Debris** ☐ Grease

Silt Depth: **4** (in.) Deposits Extent: **Heavy**
